FIBERStone & Thermbond, The Perfect Solution !

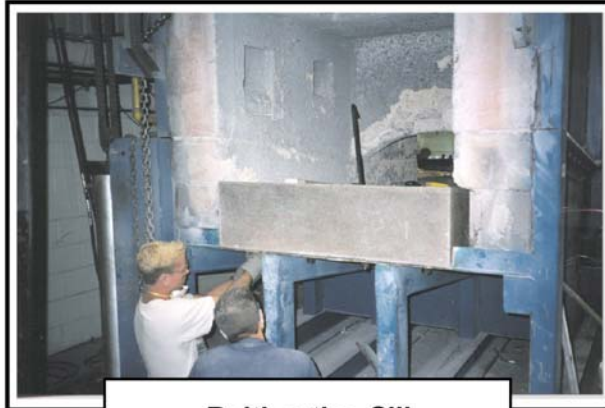
**Bolting the Sill**

Problem: This aluminum foundry was looking for a solution to a constant maintenance problem with their aluminum dry hearth furnace sill. The conventional refractory sill would crack and pieces would break off during the loading of aluminum ingot with the towmotor. The slope of the hearth was in a constant battle with the forks of the towmotor. The arch was also a regular maintenance item. The refractory plastic would spall off soon after being repaired...

Solution: A custom designed sill made in FIBERStone was bolted on to steel structure. Thermbond Formula Five was used to fill the space between the existing refractory and the sill. The arch was repaired with Thermbond Formula Nine. This new customer was very please with the successful performance of our unique products.

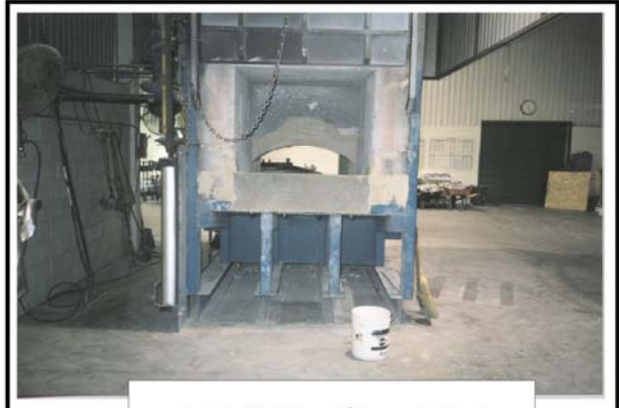
**Installation Completed**
